PROTECTA SHOCK ABSORBING LANYARDS

RECALL NOTICE

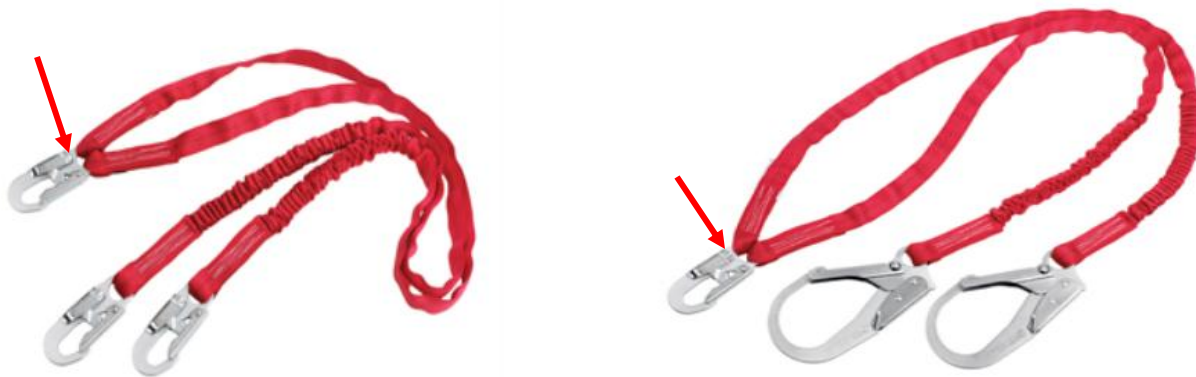
Capital Safety is aware of a reported inadvertent disconnection during use of the locking snaphook used in a series of "Y-shaped" Protecta lanyards with twin lanyard legs that both attach directly to the eye of the snaphook (part number 9502573) where it attaches to a harness d-ring. The affected lanyards may look similar to the following:

The recall includes all Protecta twin leg lanyards with legs that both attach directly to the eye of a single snaphook (part number 9502573) sold in Canada from March 2010 until October 31, 2011.

Distributors that have purchased the affected products will be notified of this recall and will in turn notify their customers. Upon notification, if you have twin leg Protecta lanyards with a snaphook (9502573) as identified in above photographs, you should immediately take the lanyard(s) out of service and contact our Customer Service department at 1-800-387-7484 to obtain a "QA" number for the return of the lanyard(s). Capital Safety will provide a like replacement Protecta lanyard at no cost. The free lanyard applies only if the returned lanyard is in proper working condition as determined by Capital Safety; if not, charges may apply.

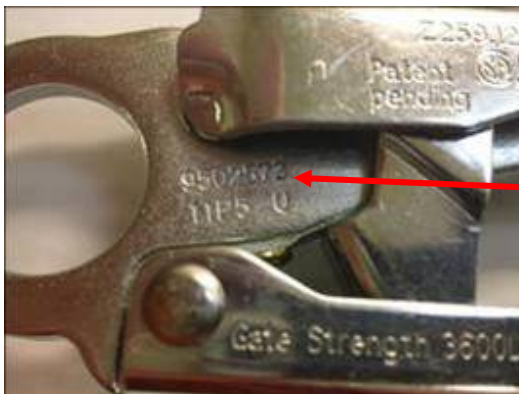
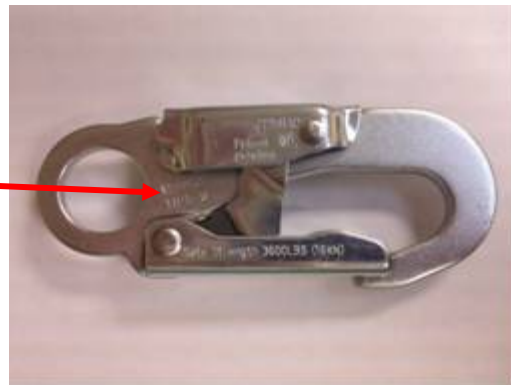
The snaphook part number (9502573) used in the affected lanyards is identified as follows:

The identified snaphook (9502573) was sold in Canada for the period from March 2010 until October 31, 2011. Lanyards without the identified snaphook are not included in this recall (twin leg lanyards with snaphook part numbers 9510218 or 9500806 are not included).

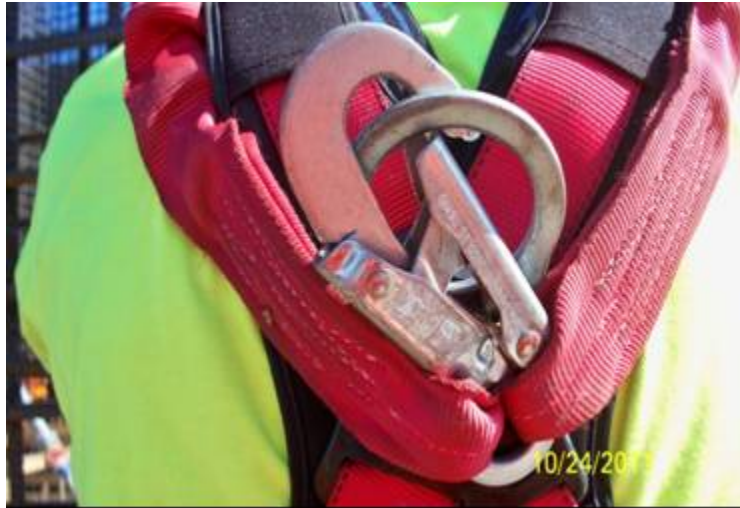
In a particular use configuration when the lanyard legs are pulled upwards simultaneously and the snaphook is compressed against the harness d-ring, the combination of forces acting on both the locking mechanism and the gate opening of the snaphook may cause the snaphook to disconnect from the d-ring. (See photo below)

The identified reason for the inadvertent disconnection is the combination of a particular style locking snaphook (9502573) together with twin lanyard legs sewn directly to the eye of the snaphook. Although there have been no reported falls or injuries associated with the use of this configuration lanyard, CS is committed to the safety of every worker at height using our products and we are determined to resolve any potential for inadvertent disconnection to occur for the reason described above.
