INSPECTION NOTIFICATION ROLLGLISS R250 DESCENDER

Inspection Notice regarding the Rollgliss® R250 Descender

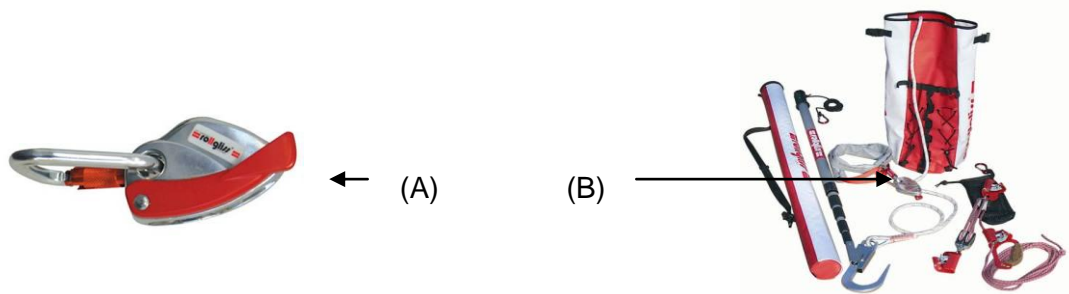
The R250 can be used as a personal *descender reference AG6250000* (see reference A) on its dedicated rope or in conjunction with the Rollgliss rescue kit *reference AG625010xx* (see reference B)

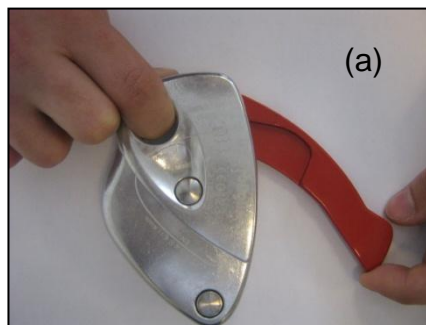
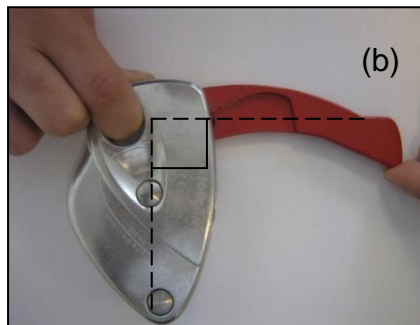
Turn the red handle (a) up so that it is perpendicular to the silver R250 body (b). The next step will require a gauge tool (c) described below.

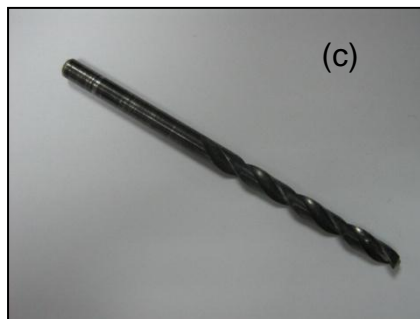
As a gauge tool (c) please use a

3.5 mm diameter drill bit
or
9/64 in diameter drill bit.

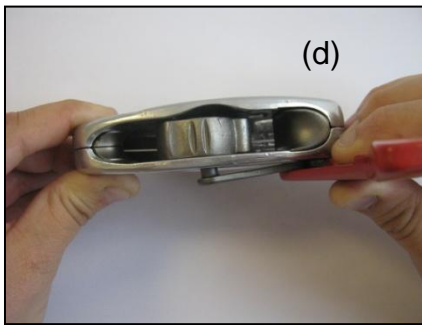
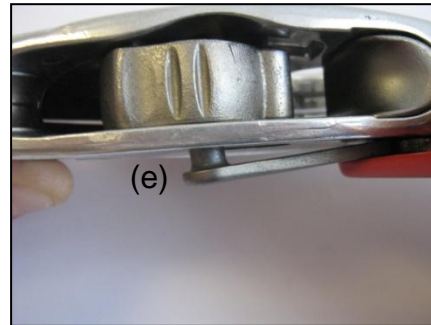
Hold the R250 horizontally with the red handle underneath and still perpendicular to the silver R250 body (d). Use the gauge tool to measure the clearance between the grey lever (e) and the R250 body.

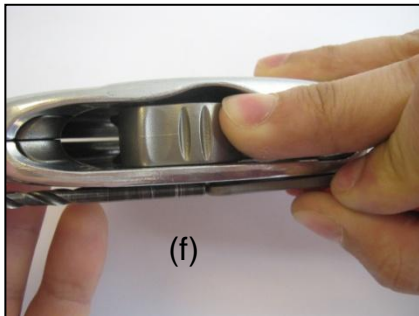
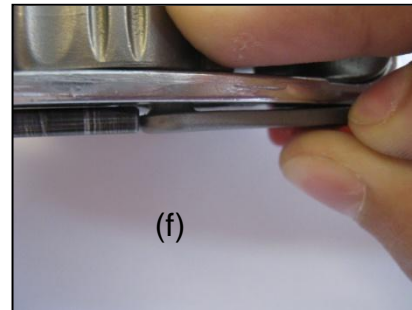
If the gauge tool does not fit in the clearance between the grey lever and the R250 body (f), then the R250 successfully passes the inspection and can be used safely.

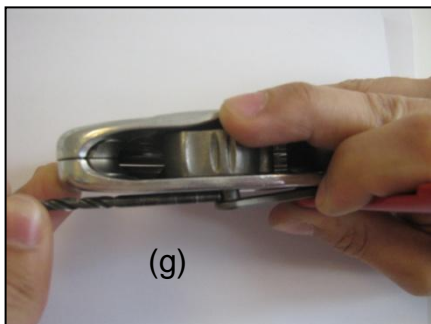
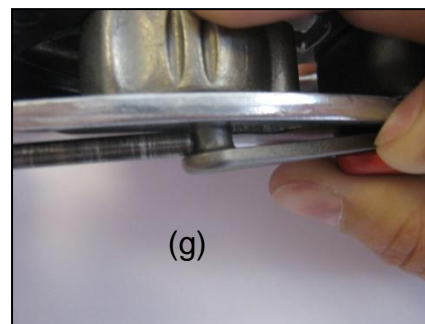
If the gauge tool fits in the clearance between the grey lever and the R250 body (g), then the R250 does not pass the inspection and must be sent back to CSG for repair.

Note that if the grey lever (e) disengages from the inner cam of the R250, the R250 must be sent back to CSG for repair. Although this is very unlikely to happen when using the R250 properly in its standard vertical orientation, if it happens it will cause the R250 to automatically lock in the stopped position, preventing the user from descending further. There would be no risk of a fall in such a situation.
