INSPECTION NOTIFICATION ROLLGLISS R250 DESCENDER

Inspection Notice regarding the Rollgliss® R250 Descender

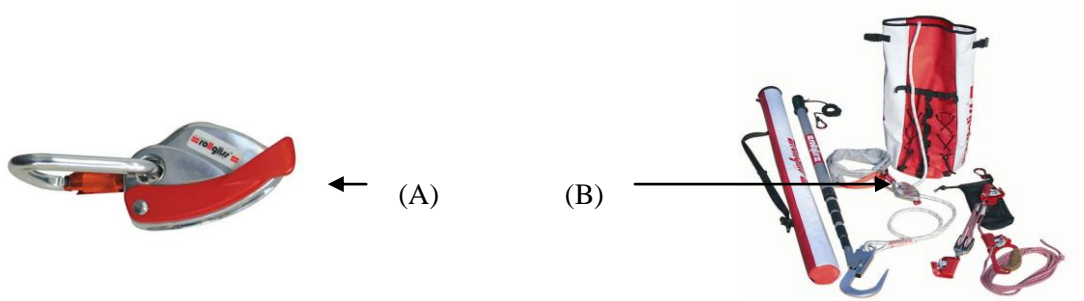
The R250 can be used as a personal *descender reference AG6250000* (see reference A) on its dedicated rope or in conjunction with the Rollgliss rescue kit *reference AG625010xx* (see reference B)

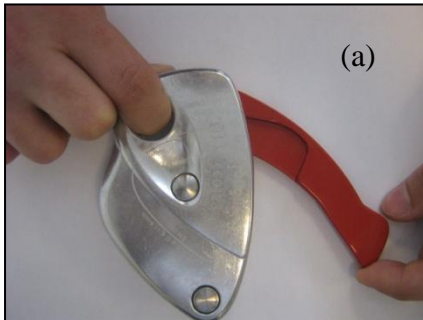
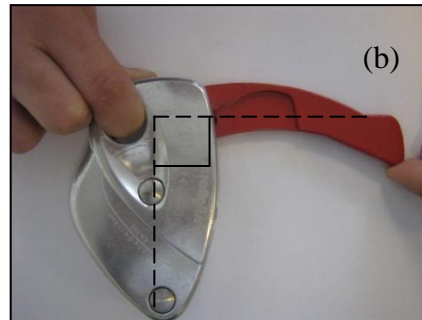
Turn the red handle (a) up so that it is perpendicular to the silver R250 body (b). The next step will require a gauge tool (c) described below.

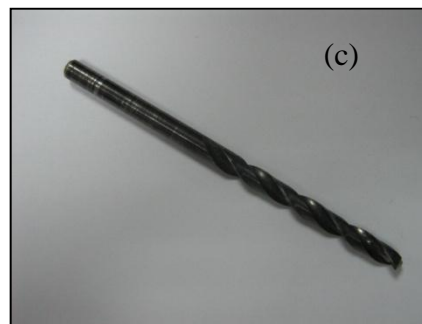
As a gauge tool (c) please use a

3.5 mm diameter drill bit
or
9/64 in diameter drill bit.

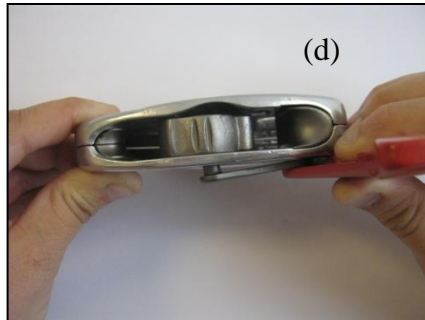
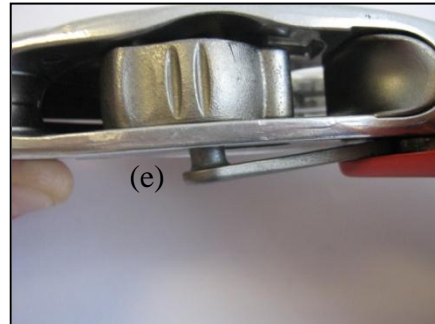
Hold the R250 horizontally with the red handle underneath and still perpendicular to the silver R250 body (d). Use the gauge tool to measure the clearance between the grey lever (e) and the R250 body.

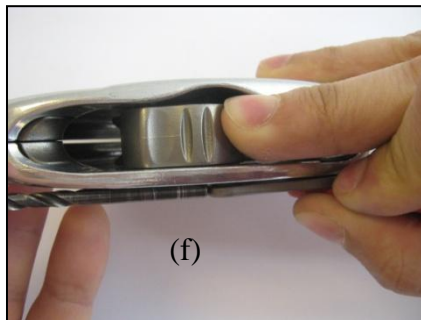
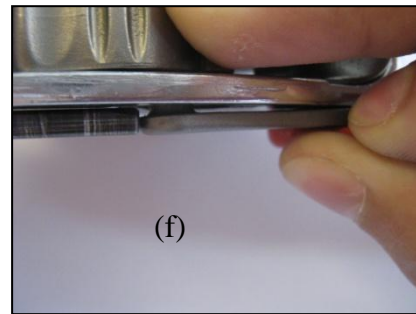
If the gauge tool does not fit in the clearance between the grey lever and the R250 body (f), then the R250 successfully passes the inspection and can be used safely.

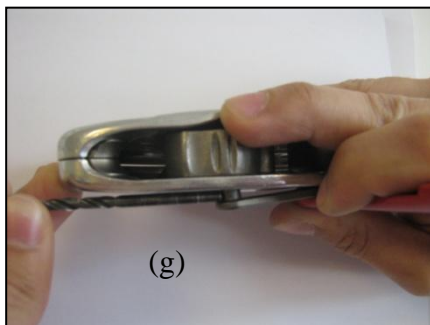
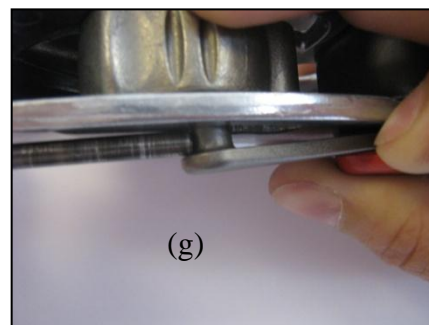
If the gauge tool fits in the clearance between the grey lever and the R250 body (g), then the R250 does not pass the inspection and must be sent back to CSG for repair.

If any user identifies that their R250 Descender does not meet the requirements of the attached inspection notice, they should contact Capital Safety's customer service department at (800-387-7484 or csgcustomerservice@capitalsafety.com) to arrange for a (QA) return number. Capital Safety in turn, will replace the unit at no charge.

Note that if the grey lever (e) disengages from the inner cam of the R250, the R250 must be sent back to CSG for repair. Although this is very unlikely to happen when using the R250 properly in its standard vertical orientation, if it happens it will cause the R250 to automatically lock in the stopped position, preventing the user from descending further. There would be no risk of a fall in such a situation.
